Bridge

SPTTE100.320

Benaming
Title | Brug

Opmerking
Comment | Trimbaan

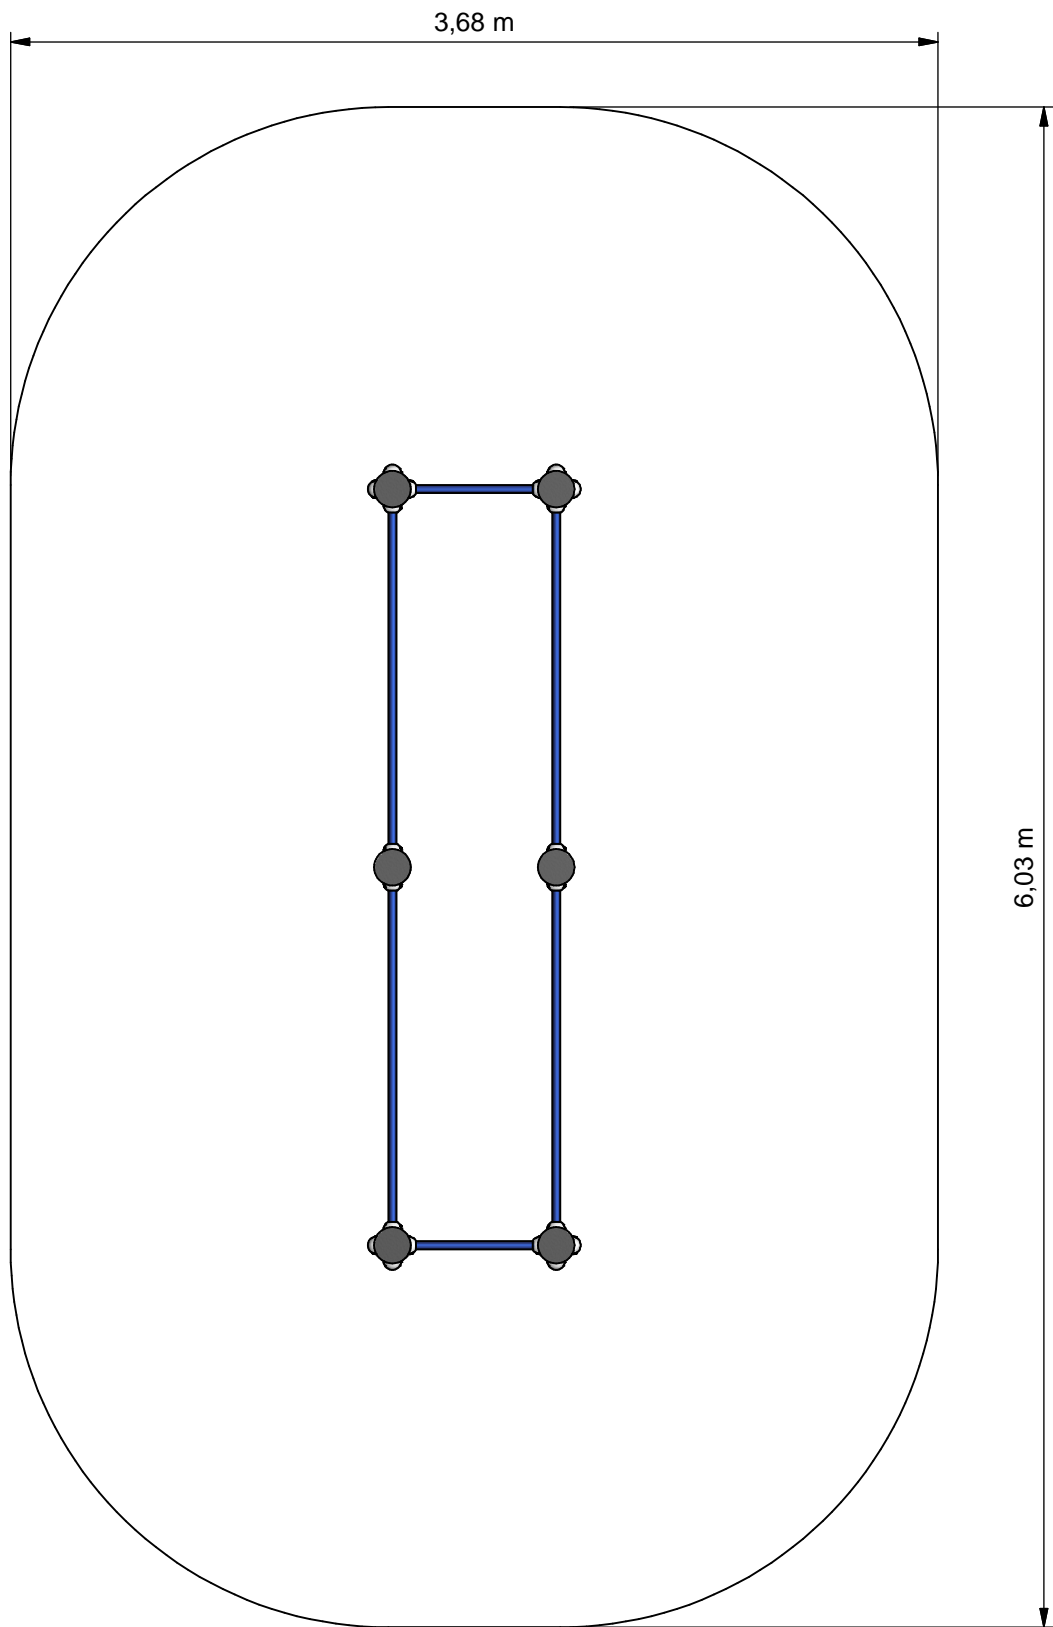
Obstakelvrije zone *Obstacle free zone*

- Opvangzone**
Impact area
- Obstakelvrije zone**
Obstacle free zone

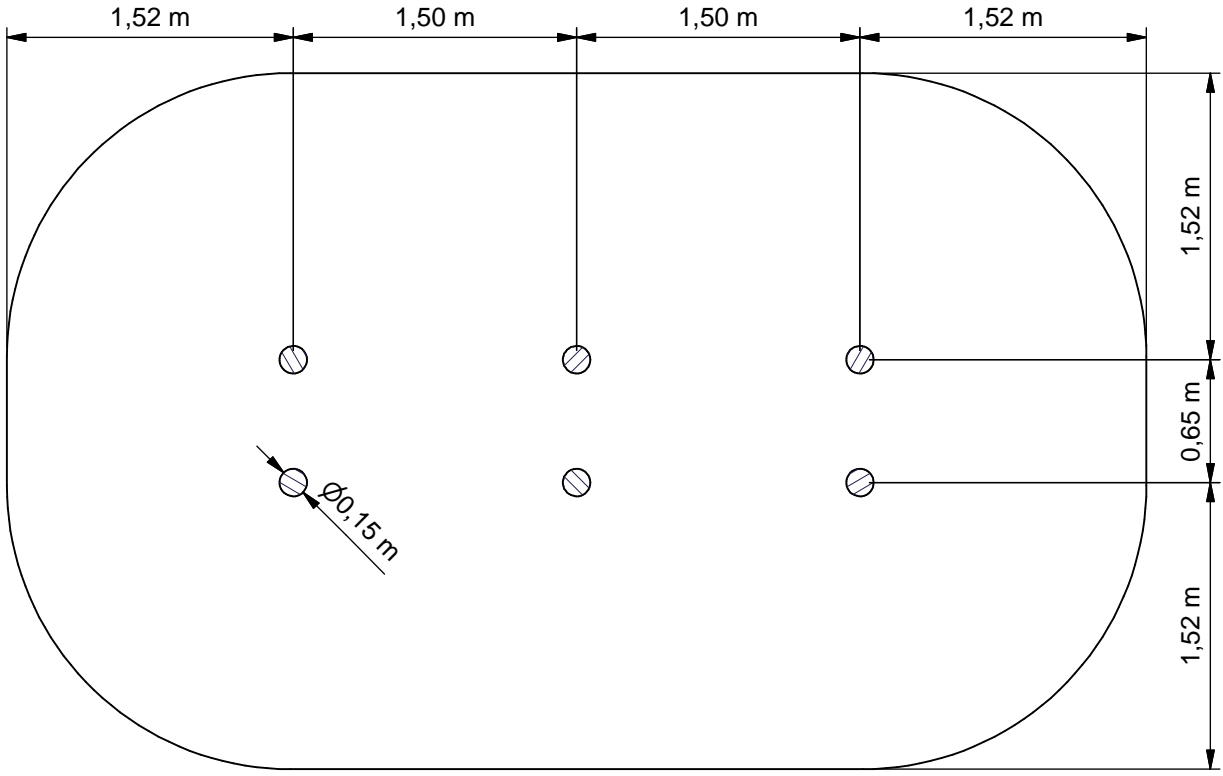
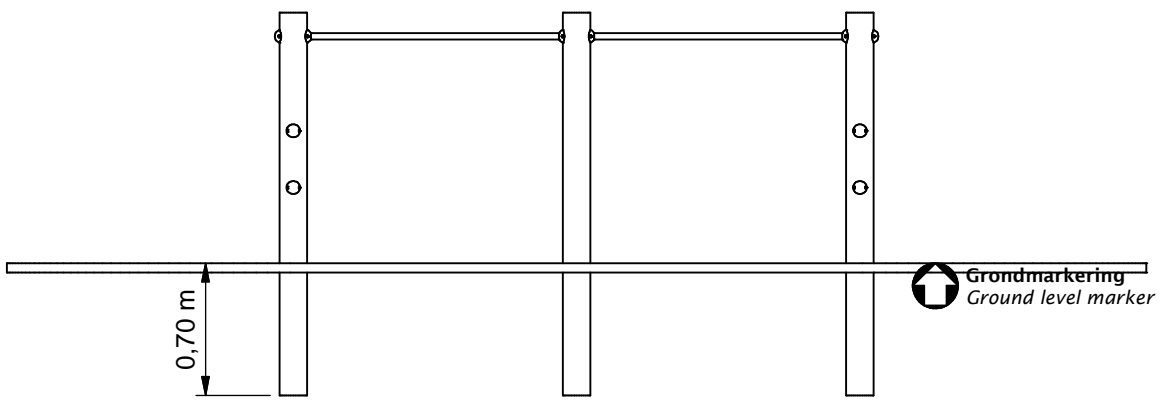
Bodemplan Groundplan

- 1 - Graaf de gaten volgens het bodemplan
- 2 - Plaats 1+2+3
- 3 - Controleer of het toestel voldoet aan de afmetingen zoals op blad 'afmetingen'
- 4 - Dicht de gaten en verdicht het zand

- 1 - Dig the holes according to the ground plan
- 2 - Place 1+2+3
- 3 - Check that the equipment conforms to the dimensions shown on sheet 'dimensions'
- 4 - Close the holes and compact the sand

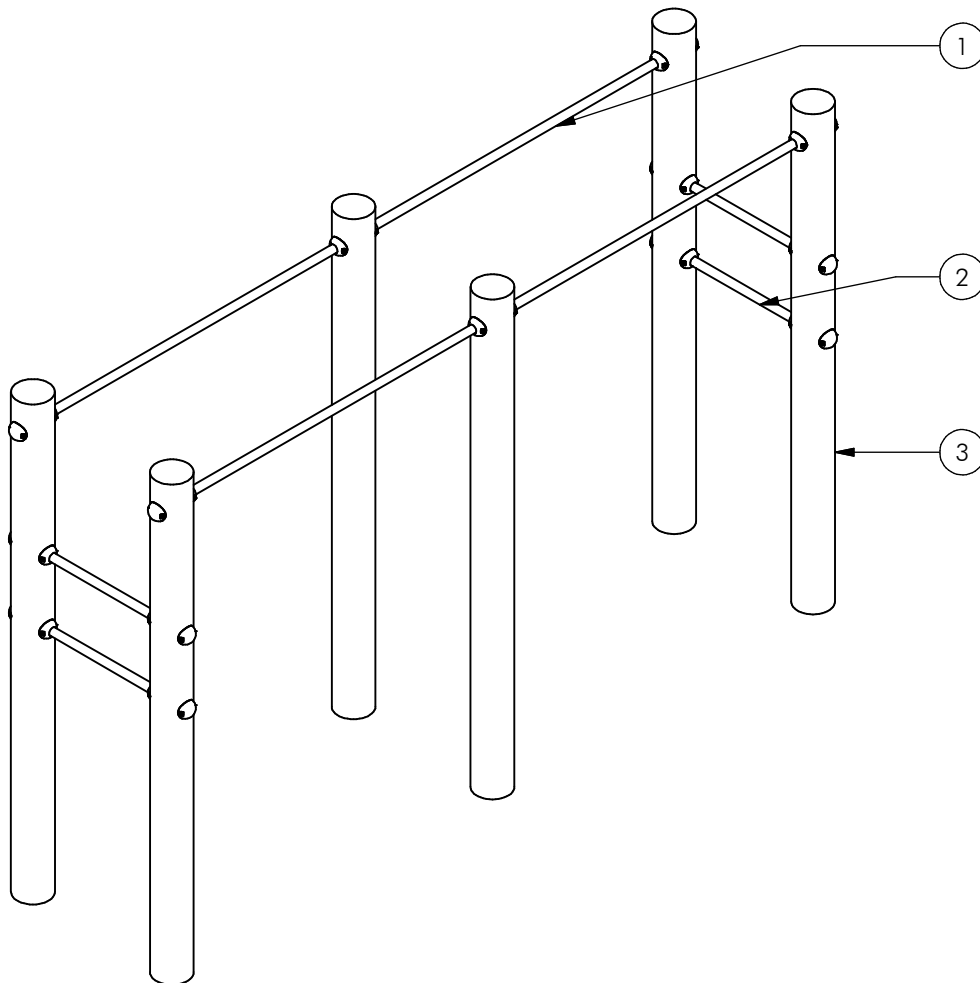
Modules Modules

Nr	#	Type	Progr.	Volgnr	Bew.	Rev.	Benaming	Opmerking
1	2	MOD	SPT	001	010		Stang 3 st.	H.o.h 1500
2	4	MOD	SPT	001	011		Stang	H.o.h. 650
3	1	MOD	SPT	100	320		Rebo Pakket	SPT.100.320

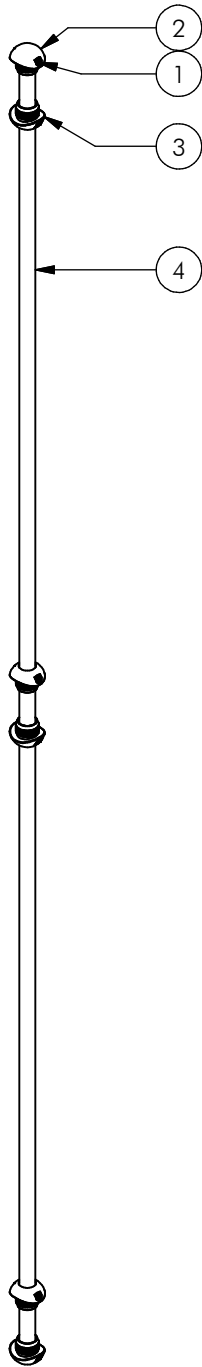
MOD SPT 001 010

Nr	#	Type	Progr.	Volgnr	Bew.	Rev.	Benaming	Opmerking
1	12	BSV	005	005	025		Zebra Pias	4,8x25 - VZ 8.8
2	2	KST	JGP	001	070		Inslagdop grijs	
3	4	KST	JGP	002	070		Inslagring grijs	
4	1	OME	318	318	502		stang Ø31.8	L= 3175 mm

Benaming
Title Stang 3 st.

Opmerking
Comment H.o.h 1500

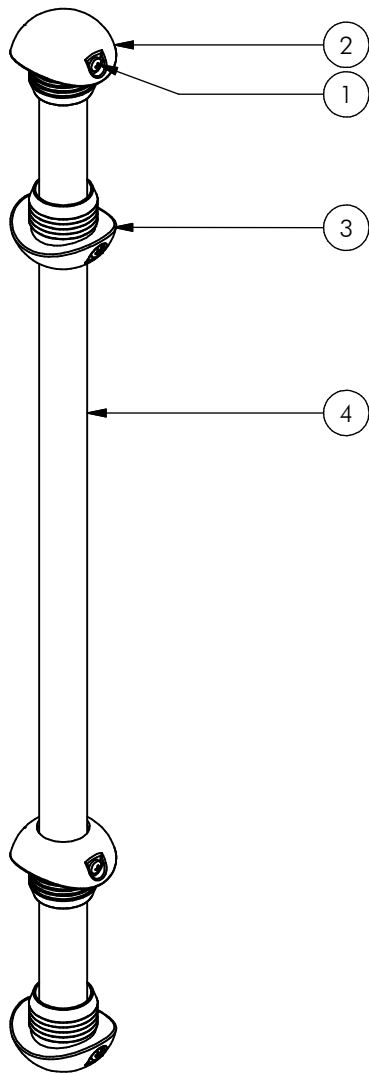
MOD SPT 001 011

Nr	#	Type	Progr.	Volgnr	Bew.	Rev.	Benaming	Opmerking
1	8	BSV	005	005	025		Zebra Pias	4,8x25 - VZ 8.8
2	2	KST	JGP	001	070		Inslagdop grijs	
3	2	KST	JGP	002	070		Inslagring grijs	
4	1	OME	318	083	502		Pijp Ø31.8 x 2.6	L=825 mm

Benaming Title Stang
 Opmerking Comment H.o.h. 650
 Datum Date 9-11-2015

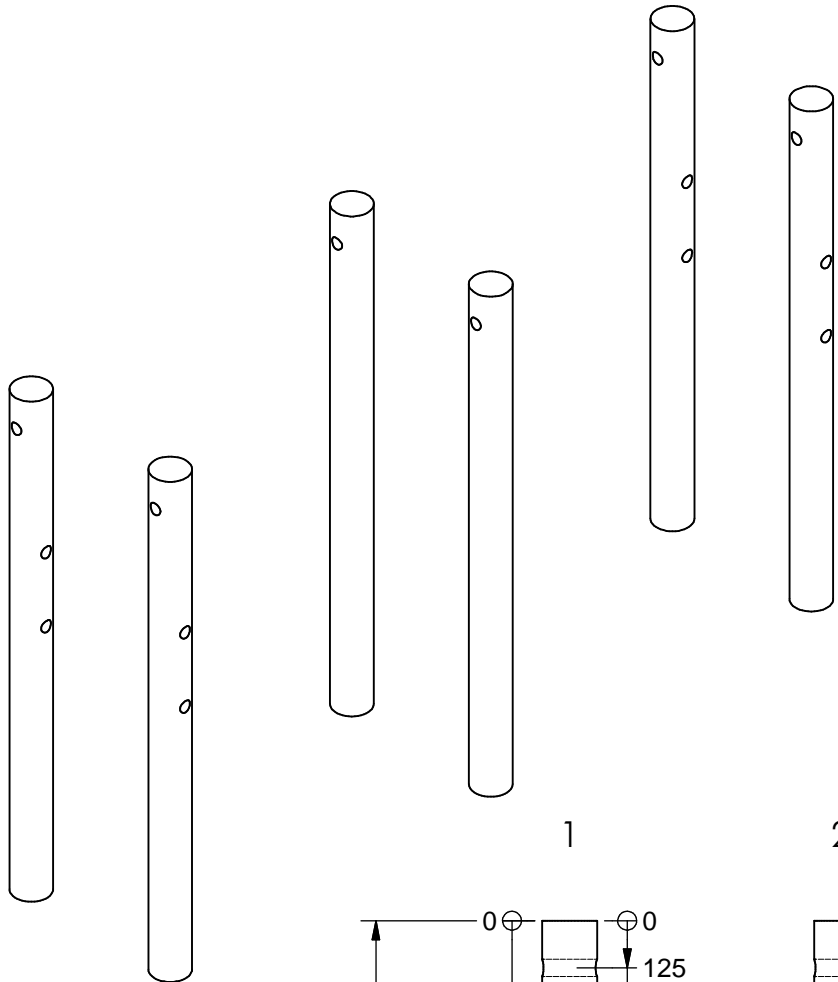
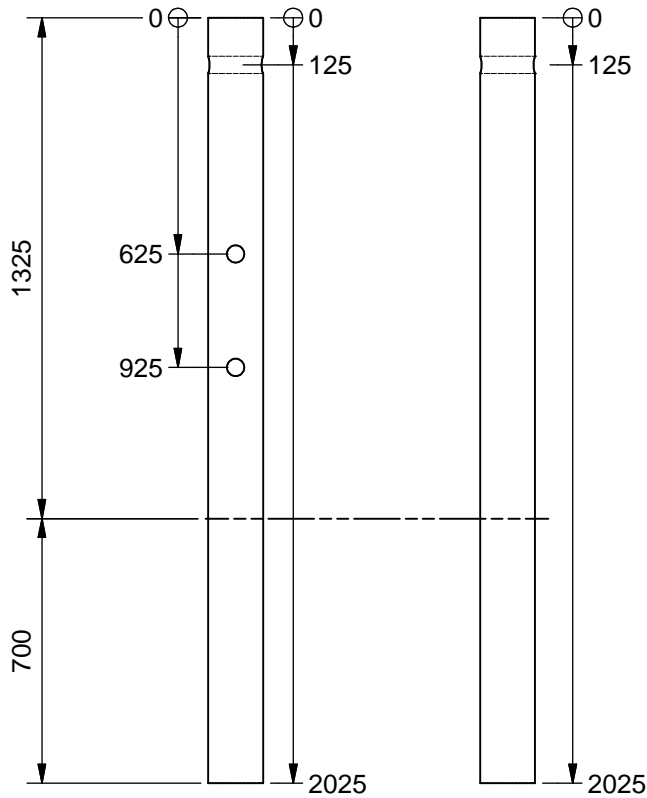
MOD SPT 100 320

All holes $\varnothing 46$ unless otherwise stated.
 All holes pierce unless otherwise stated.
 All the holes in the heart of the post, unless otherwise stated.

Nr	#	Type	Progr.	Volgnr	Bew.	Rev.	Benaming	Opmerking
1	4	ORE	SPT	001	031		Rebo $\varnothing 145$	L= 2025
2	2	ORE	SPT	001	032		Rebo $\varnothing 145$	L= 2025

Benaming
 Title Rebo Pakket
 Opmerking
 Comment SPT.100.320
 Datum
 Date 9-11-2015
