Climbing equipment

SPT100.280

Benaming / Title: Spring / rektoestel

Opmerking / Comment: Trimbaan

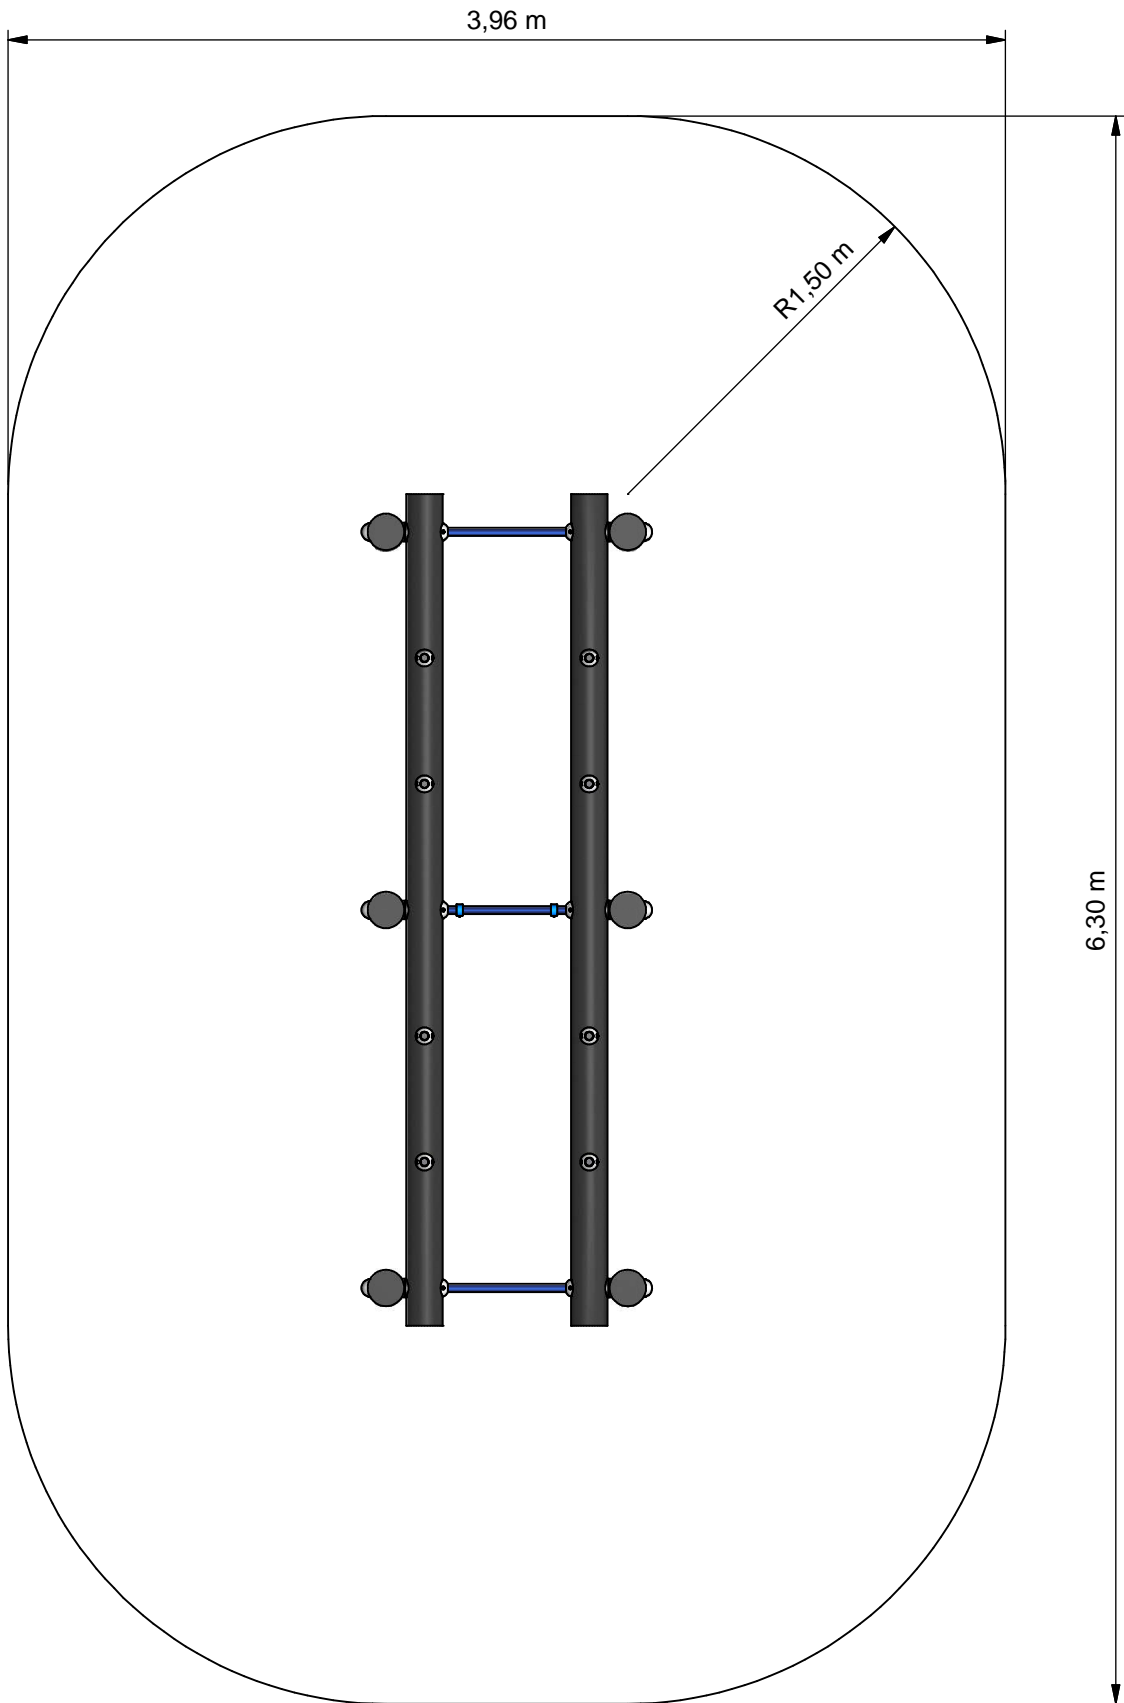
TOE SPT 100 280

- Opvangzone
Impact area
- Obstakelvrije zone
Obstacle free zone

Obstakelvrije zone *Obstacle free zone*

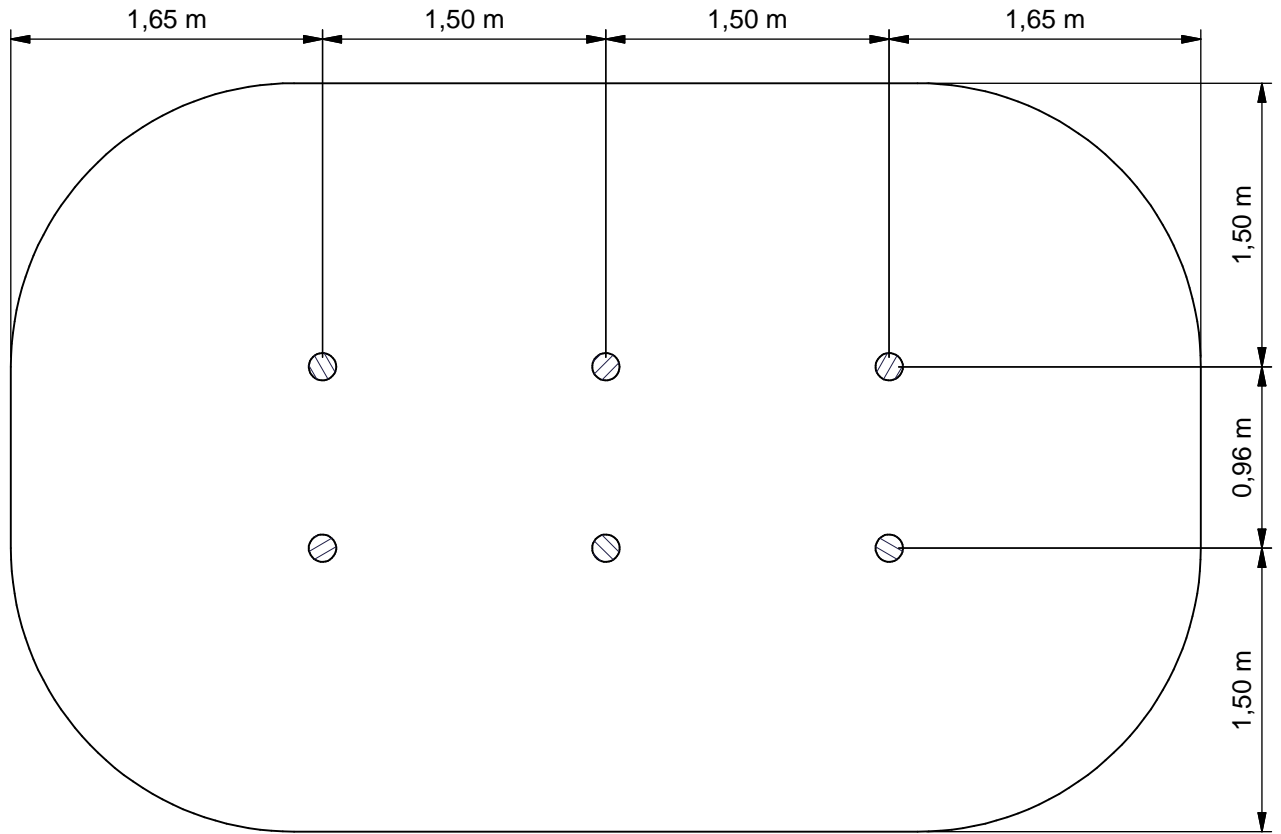
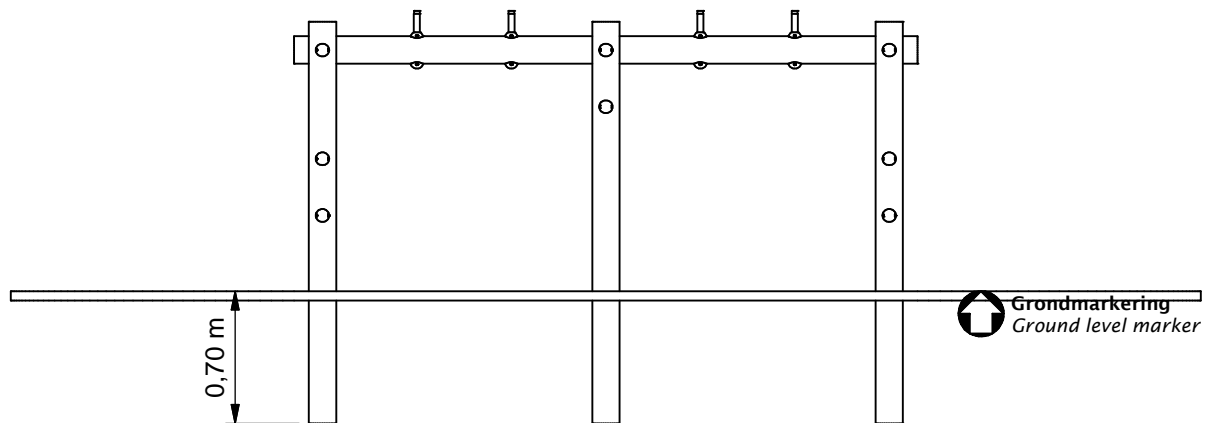
TOE SPT 100 280

Bodemplan Groundplan

- 1 - Graaf de gaten volgens het bodemplan
- 2 - Plaats 5, verbind deze met 1+2+3+4
- 3 - Controleer of het toestel voldoet aan de afmetingen zoals op blad 'afmetingen'
- 4 - Dicht de gaten en verdicht het zand

- 1 - Dig the holes according to the ground plan
- 2 - Place 5, attach it between with 1+2+3+4
- 3 - Check that the equipment conforms to the dimensions shown on sheet 'dimensions'
- 4 - Close the holes and compact the sand

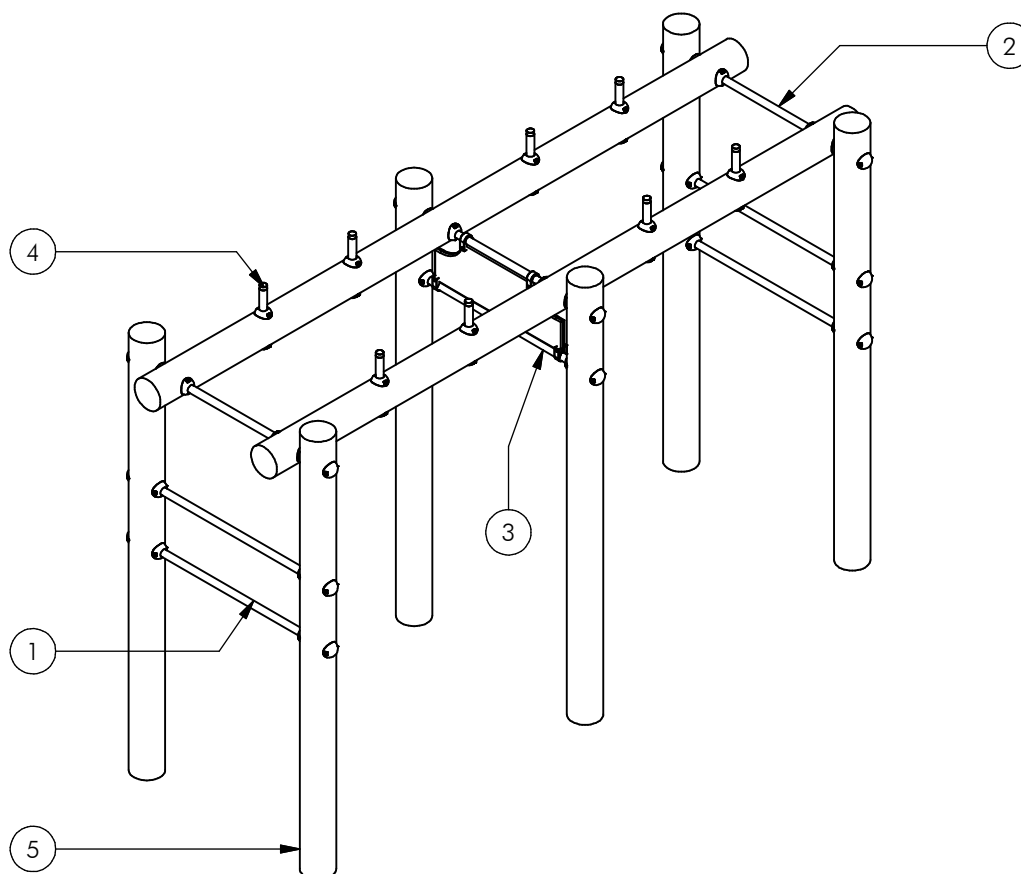
TOE SPT 100 280

Modules Modules

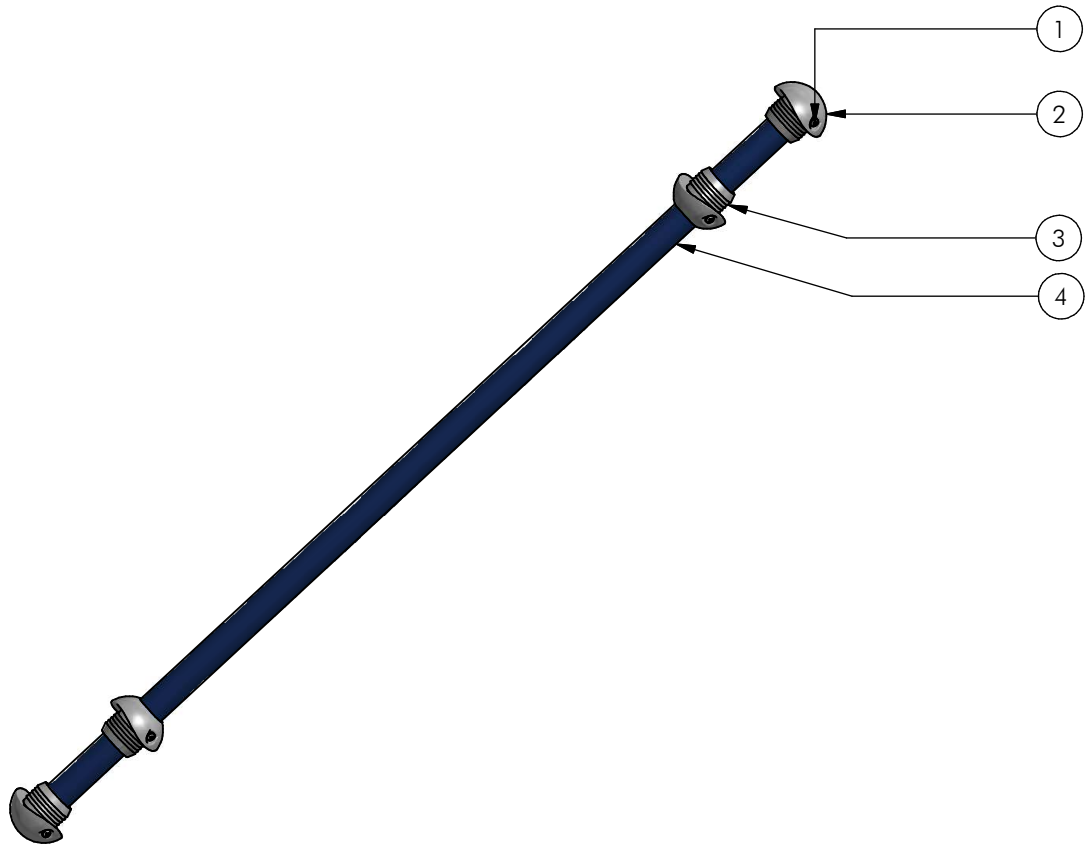
MOD JGP 002 051

Benaming
Title STANG Doppen Grijs

Samenstelling module *Assembly module*

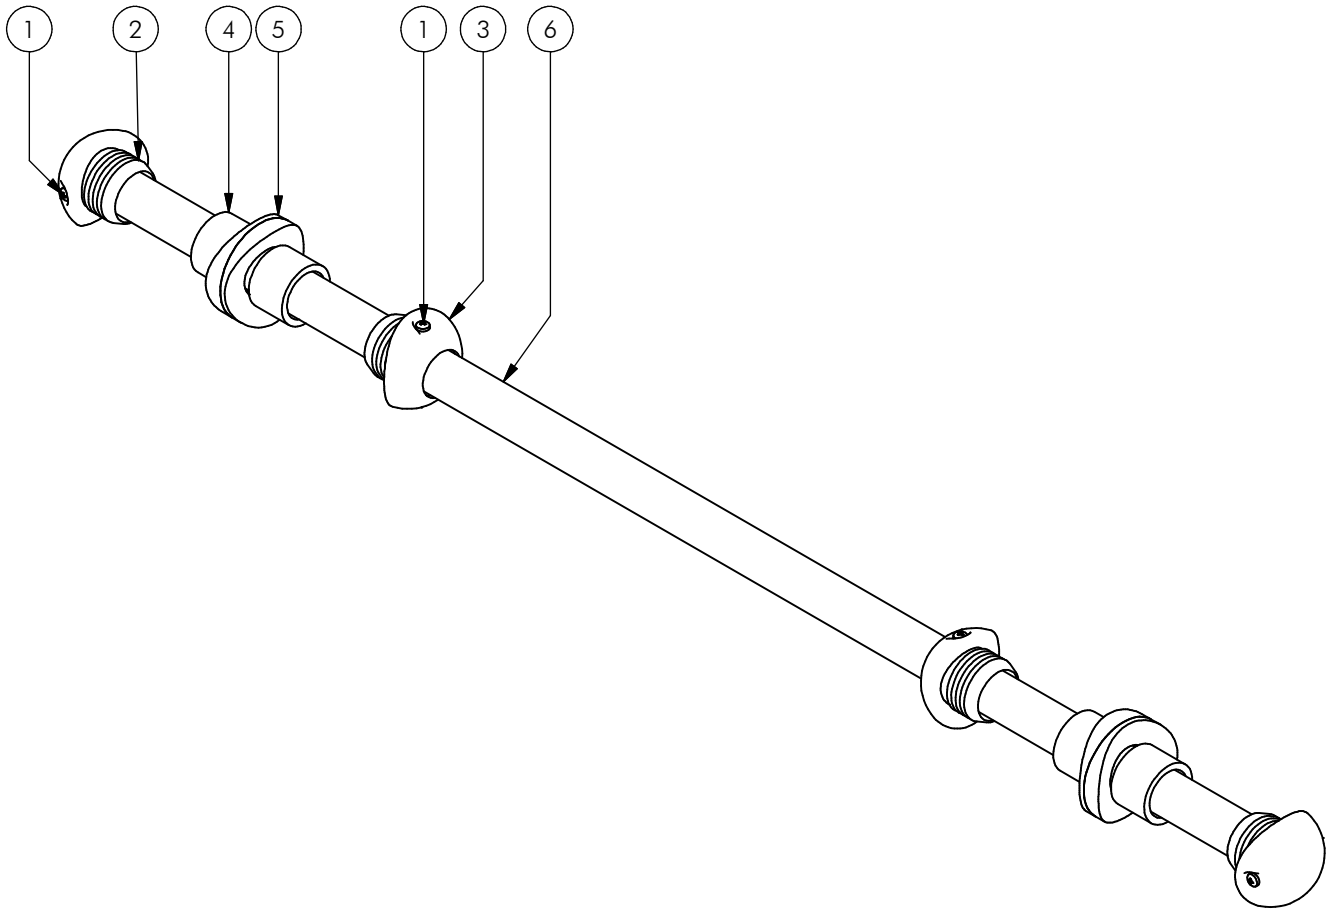
MOD SPT 001 006

Benaming / Title: Stang staander/ligger
 Opmerking / Comment: h.o.h. 960 mm
 Datum / Date: 4-11-2015

Samenstelling module Assembly module

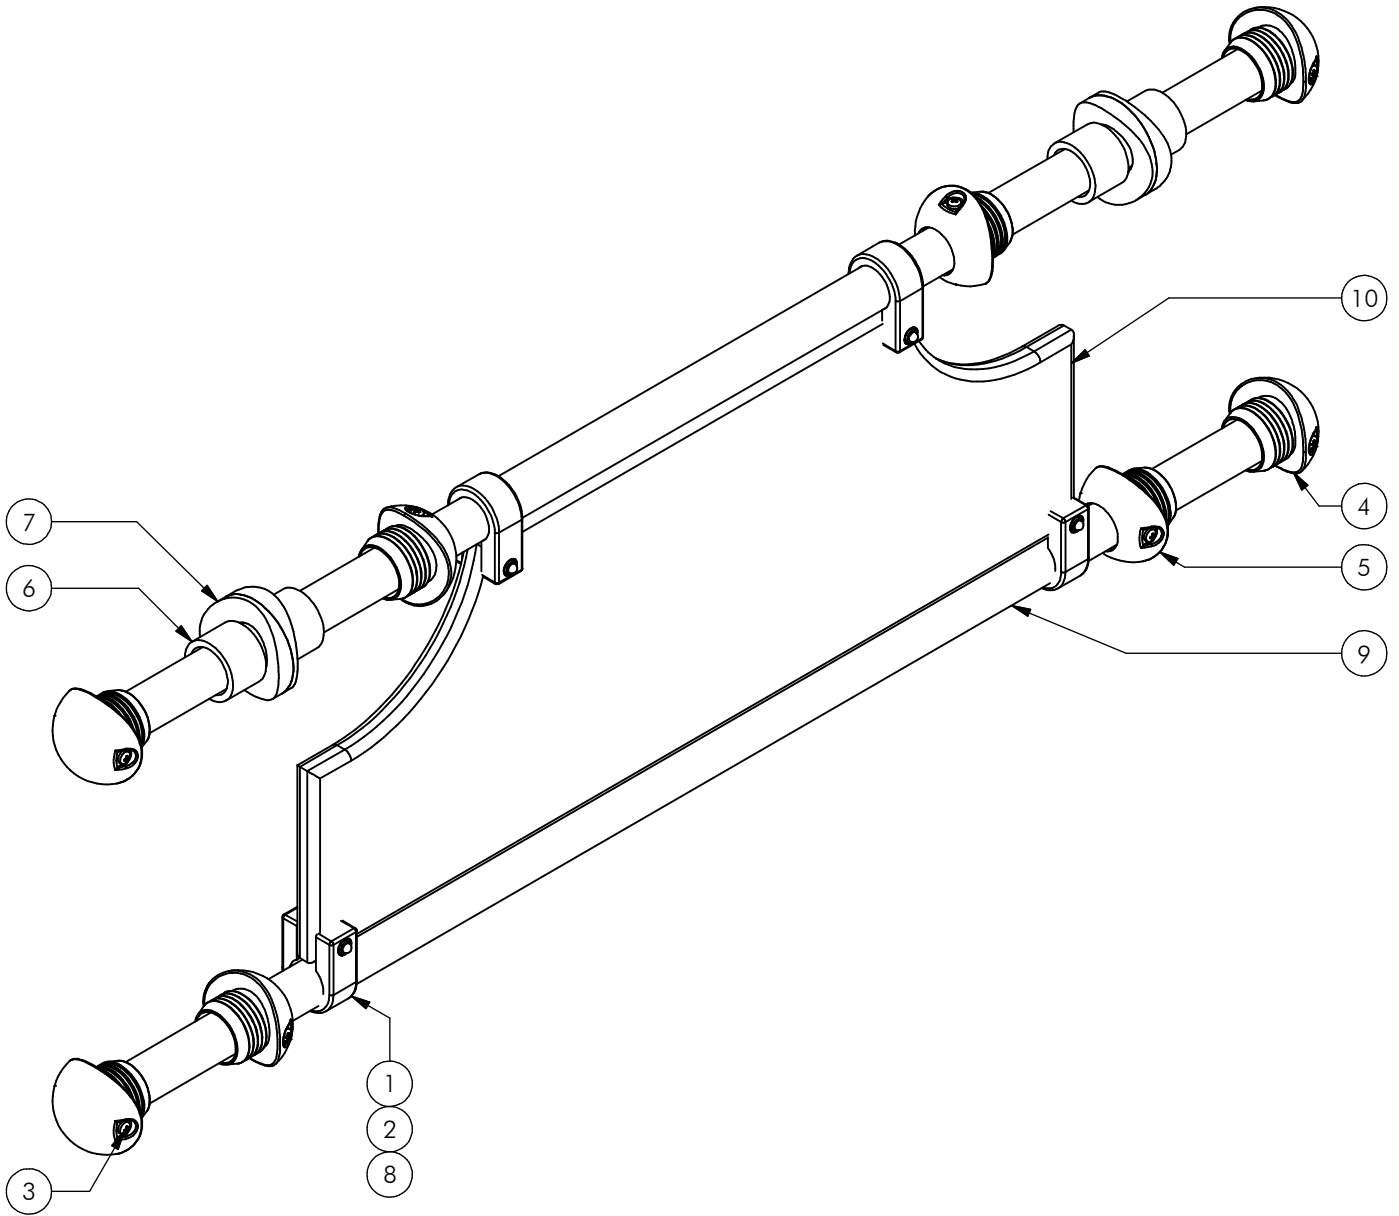
MOD SPT 001 007

Benaming Title Schotje
 Opmerking Comment Springtoestel
 Datum Date 4-11-2015

Samenstelling module Assembly module

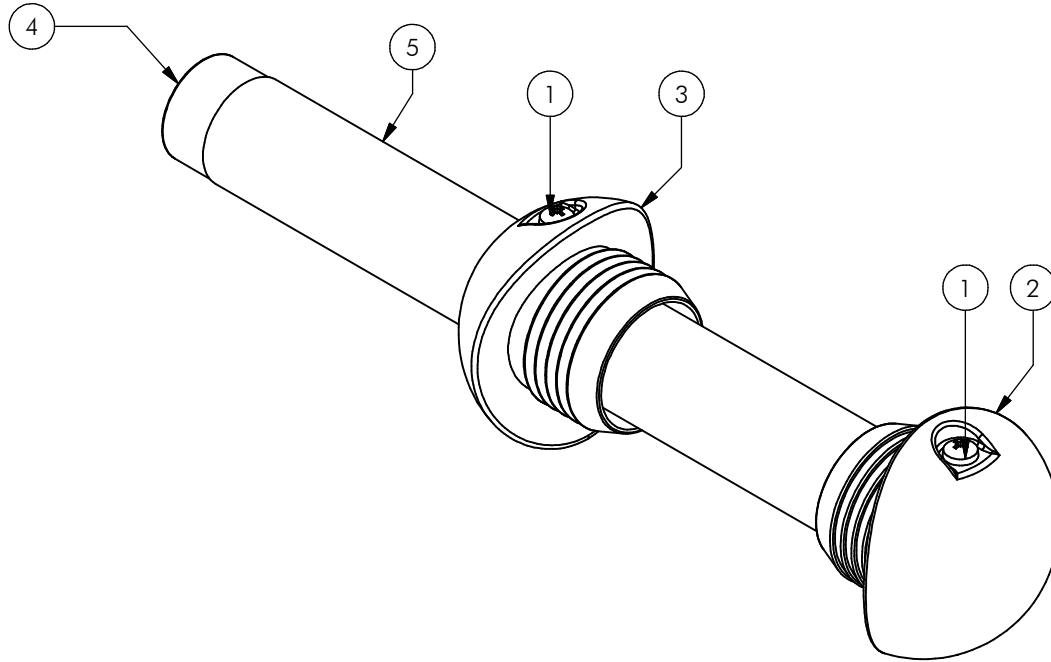
MOD SPT 001 008

Benaming
Title Handgreep

Samenstelling module Assembly module

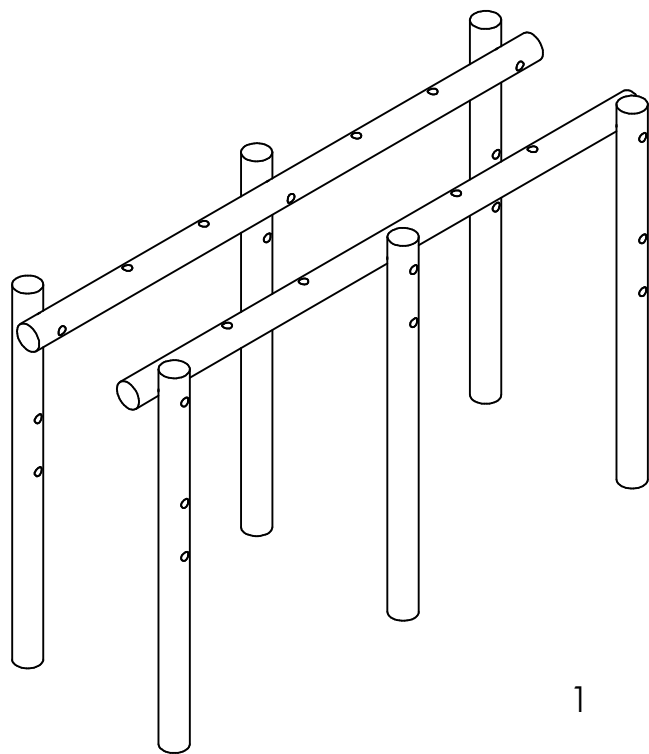
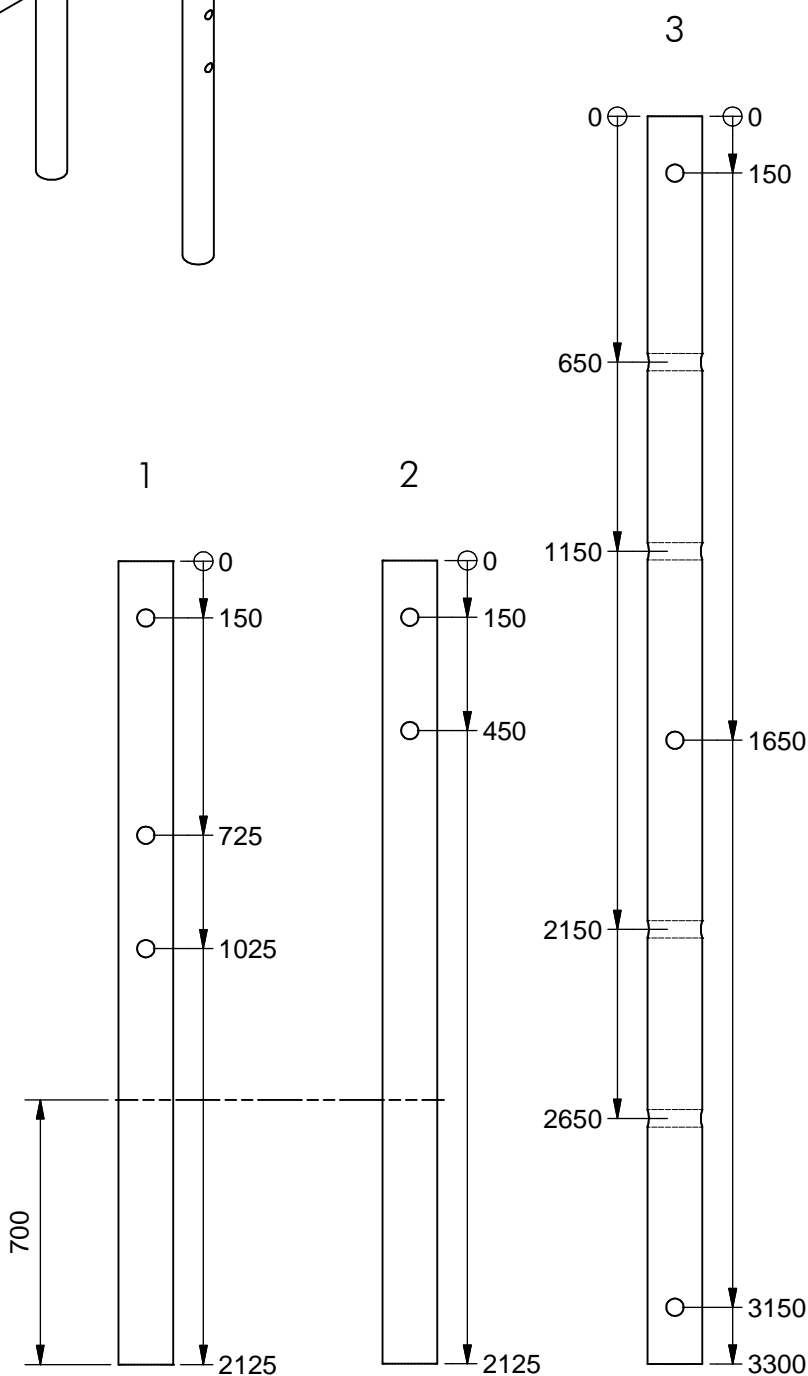
MOD SPT 100 280

All holes $\varnothing 46$ unless otherwise stated.
 All holes pierce unless otherwise stated.
 All the holes in the heart of the post, unless otherwise stated.

Benaming
 Title Rebo Pakket

Samenstelling module Assembly module
